## EXPERIMENTAL RESULTS OBTAINED IN A PROACTIVE MAINTENANCE OF INDUSTRIAL EQUIPMENT OPERATING IN LUKOIL REFINERY

This example is an electric pump that serves a supply power having a boiler flow with a capacity 240t / h (shown in Figure 1 and Figure 2); the equipment was installed in March 2015. The main features of this equipment (the electric power - EPA no. 3) are as follows:

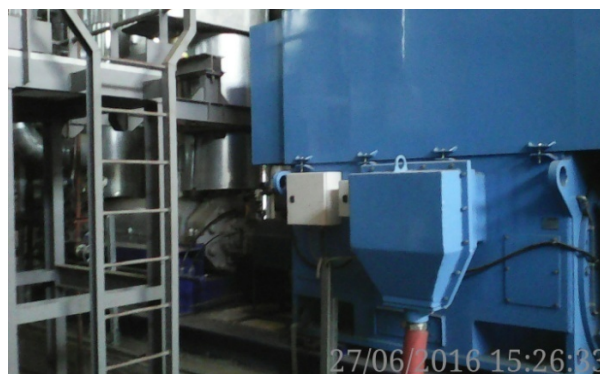
Figure 1 shows the placement of electric motor and pump produced by ELECTROPUTERE Romanian company.

Fig. 1. The electric motor and pump No. 3

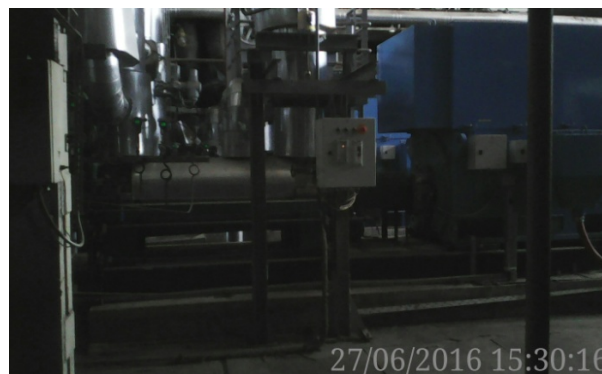
Figure 2 shows the location of the equipment seen from another angle from which we can observe the supply pump and motor, local control panel.

Fig. 2 – The electric motor, local control panel.

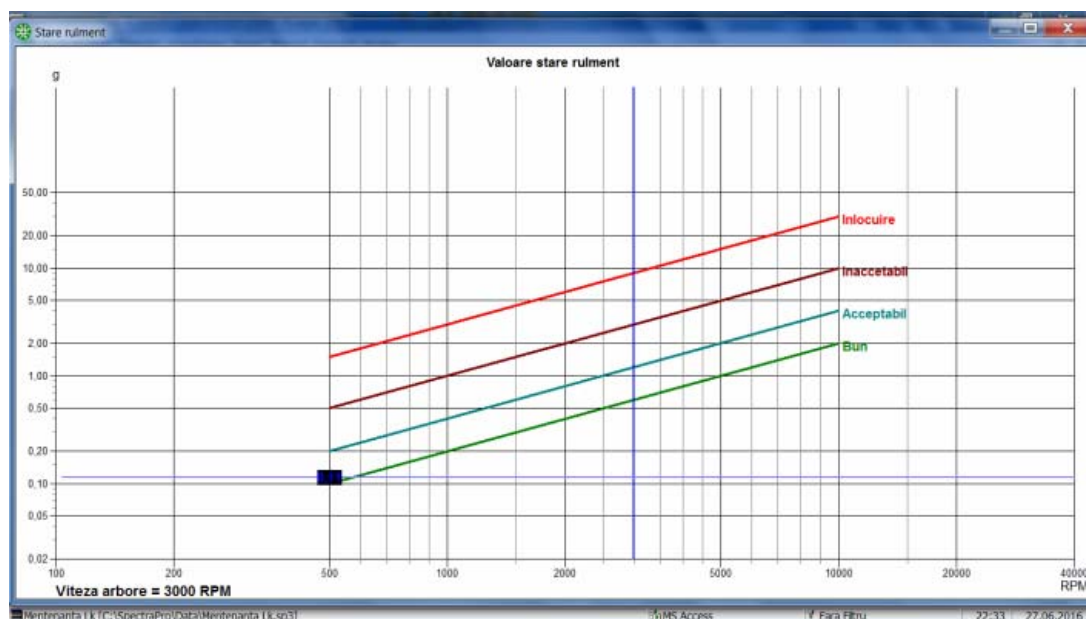
Figure 3 presents the variation wear of mounted bearing No. 1 measured in units of gravitational acceleration  $g$ , depending on the rotation speed of the machine  $RPM$ . According to the four diagrams of Figure 3, the bearing wear of mounted bearing no. 1 is  $0.11 g$  - this is a very good value, considering that was acquired after equipment operating longer than one year (measured on the period 27.05.2015 - 28.06.2016).

Fig. 3 – EPA nr.3 : The bearing wear of mounted bearing no. 1

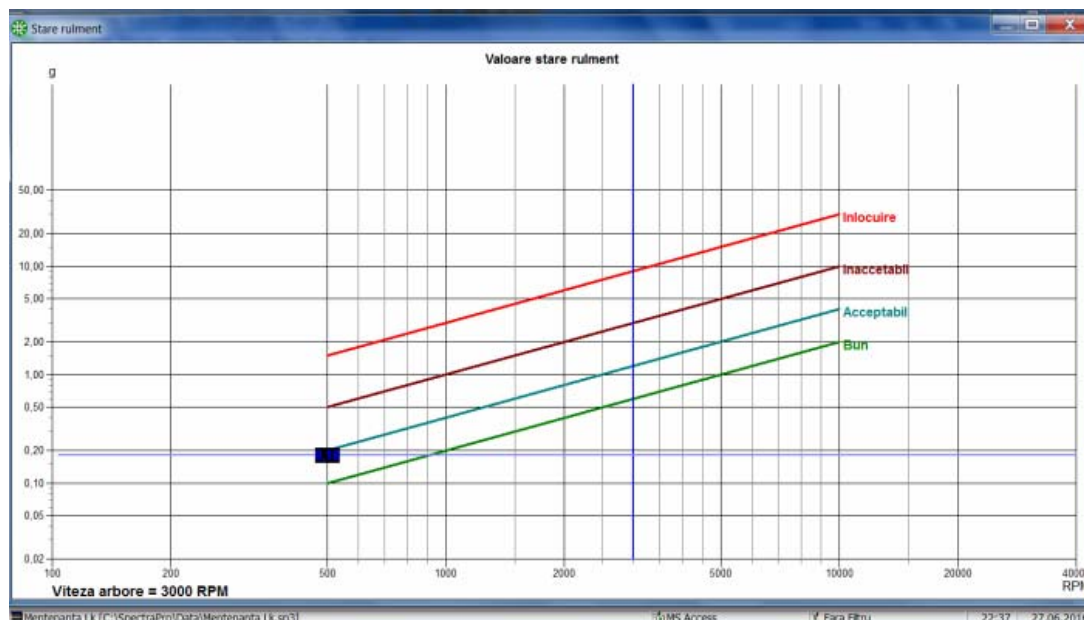
Figure 8 presents the variation wear of mounted bearing No. 2 measured in units of gravitational acceleration  $g$ , depending on the rotation speed of the machine RPM.

According to the four diagrams of Figure 8, the bearing wear of mounted bearing no. 2 is  $0.18 g$  - this is a very good value, considering that was acquired after equipment operating longer than one year (values are measured on 27.06.2016).

Fig. 8 – EPA No.3 : The bearing wear of mounted bearing no. 2

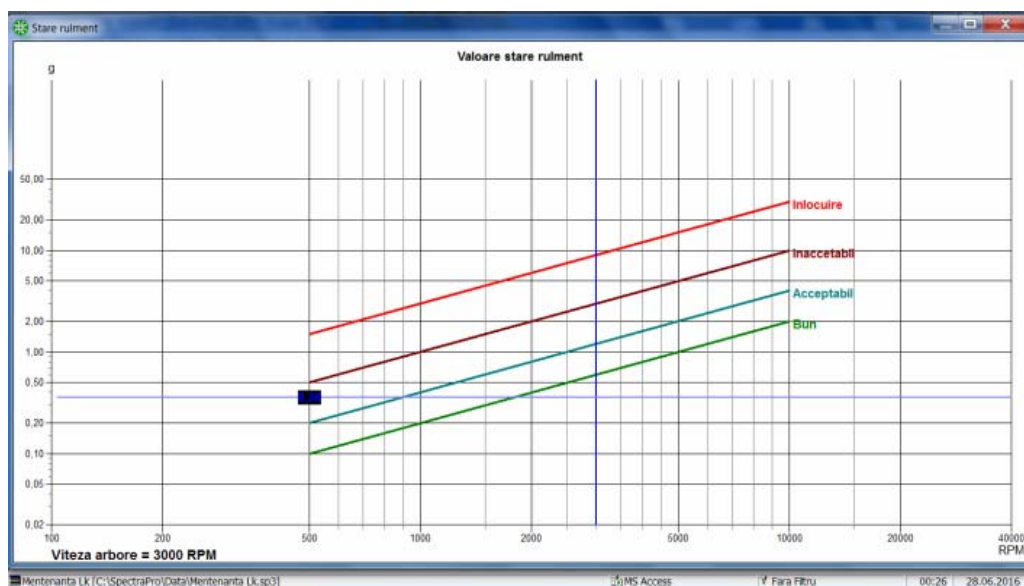
Figure 12 presents the variation wear of mounted bearing No. 3 measured in units of gravitational acceleration  $g$ , depending on the rotation speed of the machine RPM.

According to the four diagrams of Figure 12, the bearing wear of mounted bearing no. 2 is  $0.36 g$  - this is a very good value, considering that was acquired after equipment operating longer than one year (values are measured on 28.06.2016).

Fig. 12 – EPA No.3 : The bearing wear of mounted bearing no. 3

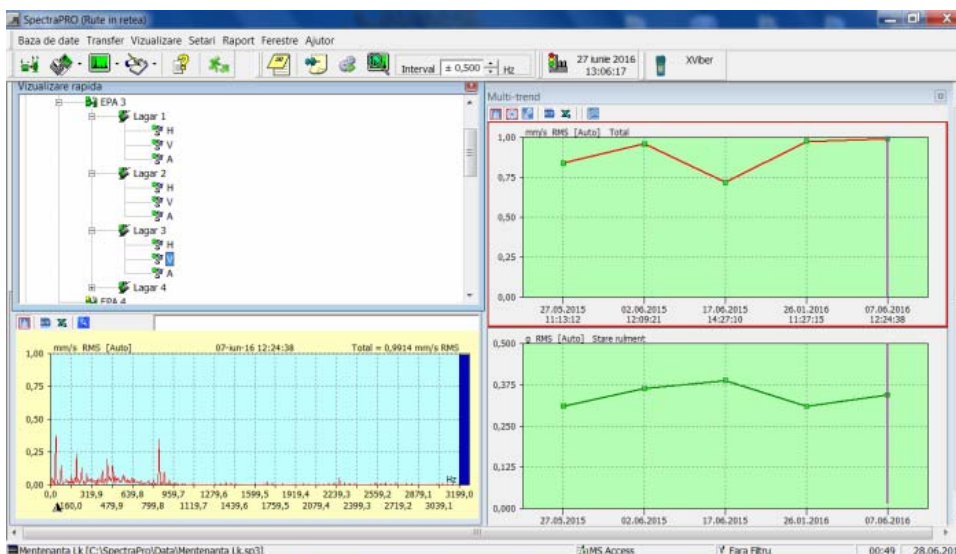
- In the horizontally direction: RMS OVERALL= $1.182 \text{ mm/s}$ , the bearing wear= $0.36 g$  (Figure 13).
- The vertical direction: RMS OVERALL = $0.991 \text{ mm/s}$ , the bearing wear = $0.34 g$  (Figure 14).
- In the axial direction: RMS OVERALL= $0.572 \text{ mm/s}$ , the bearing wear =  $0.61 g$  (Figure 15).

Fig. 14 – EPA no.3 : Bearing No 3 – Vertical direction

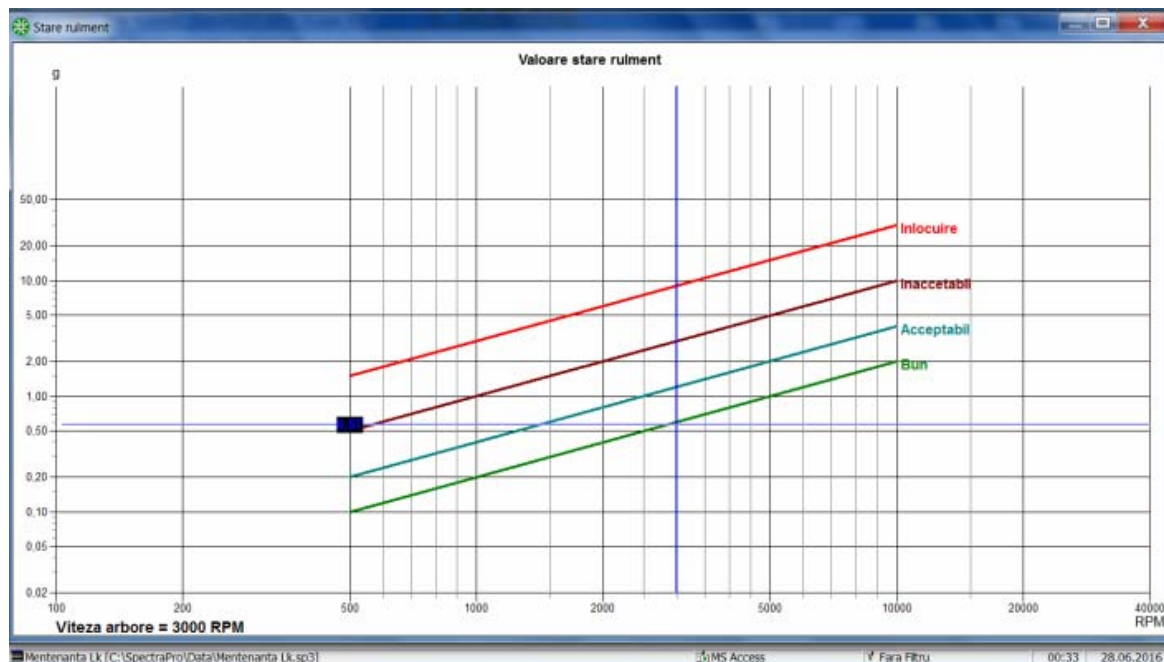
Figure 16 presents the variation wear of mounted bearing No. 4 measured in units of gravitational acceleration  $g$ , depending on the rotation speed of the machine RPM.

According to the four diagrams of Figure 12, the bearing wear of mounted bearing no. 4 is  $0.57 g$  - this is a very good value, considering that was acquired after equipment operating longer than one year (values are measured on 28.06.2016).

Fig. 16 – EPA No.3 : The bearing wear of mounted bearing no. 4
