## INNOVATIVE SOLUTIONS BASED ON NANOMATERIALS FOR PROTECTION AND CONSERVATION OF CULTURAL HERITAGE MONUMENTS

**Keywords:** nanomaterials, consolidants, hydroxyapatite

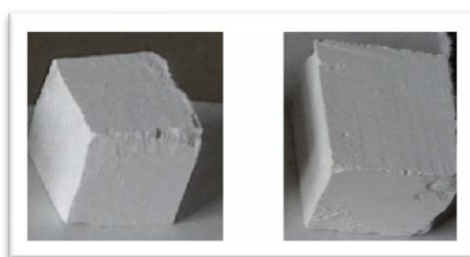
Fig. 1. Chalk stone non-treated (left) and treated with HAp (right)

nanomaterials for the conservation and restoration area has been investigated for solving several problems, such as incomplete lime carbonation process, limited depth penetration and the formation of thin white superficial layers. The aim of this paper is to test some nano-consolidants based on hydroxyapatite, metallo-hydroxyapatite (Mg, Sr, Ba),  $\text{Ca}(\text{OH})_2$ ,  $\text{Mg}(\text{OH})_2$  for consolidating the chalk stone used in Basarabi Church building monument from Dobrogea region (Romania). This monument was built
